Bevercotes Beck –Catchment Mitigation Desk Study

Adam Freer- River Idle Catchment Officer

October 2016

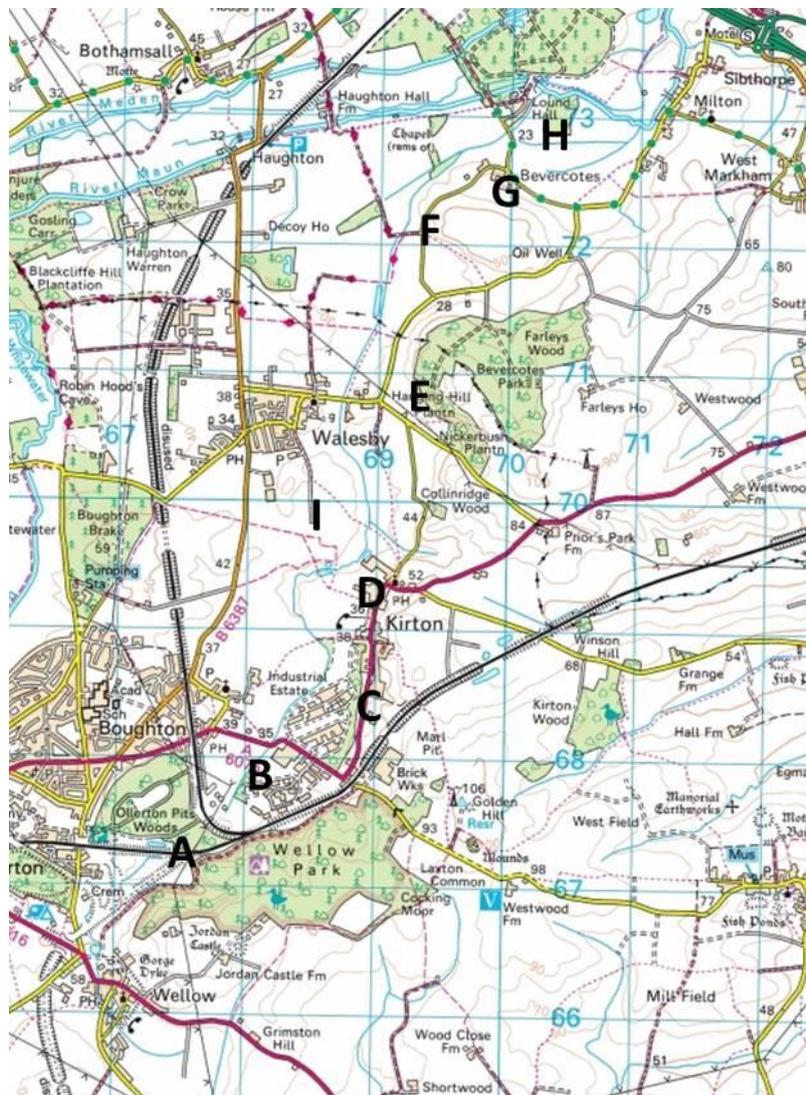
Figure 2 Potential pollutant sources within the Bevercotes Beck catchment.

The former Ollerton Colliery was redeveloped and forested (now Ollerton Park) (fig.2). Runoff from the former spoil tips is diverted via water control structures/features into a retention pond. While such drainage schemes are usually self-contained, it is unknown whether there may be a connection into Boughton Dyke. If this was the case, the tip may be a potential source of heavy metals into the stream system (although no data to support this).

Boughton sewage treatment works (STW) discharges treated effluent continuously into Boughton Dyke, which becomes Bevercotes Beck. This may represent a continuous point source of nutrients and, in particular orthophosphates to the watercourse. The low flow regime in the stream suggests that effluent discharges from the STW may make up a considerable proportion of the stream base flow. In turn this may limit the dilution of the final effluent and exacerbate phosphorus/BOD concentrations.

Both tributaries of Bevercotes beck flow adjacent to or through several areas which may be sources of hydrocarbons and industrial contaminants. These include a construction depot, a scrapyard and Boughton industrial estate. The extent to which the watercourse receives water form surface drainage is unclear.

Manor Farm at Kirton is predominantly an indoor pig/ outdoor cattle unit which backs onto both Bevercotes Beck and a connected drainage trench which then flows into the main channel. Aerial imagery shows a large slurry lagoon or pond located directly next to the watercourse, which potentially represents a significant source of P and BOD. Depending the age and construction of the pond/pit, the contents may be permeating through into the watercourse through the earth bank. The farm also appears to have several AD silage clamps which may leach effluent.

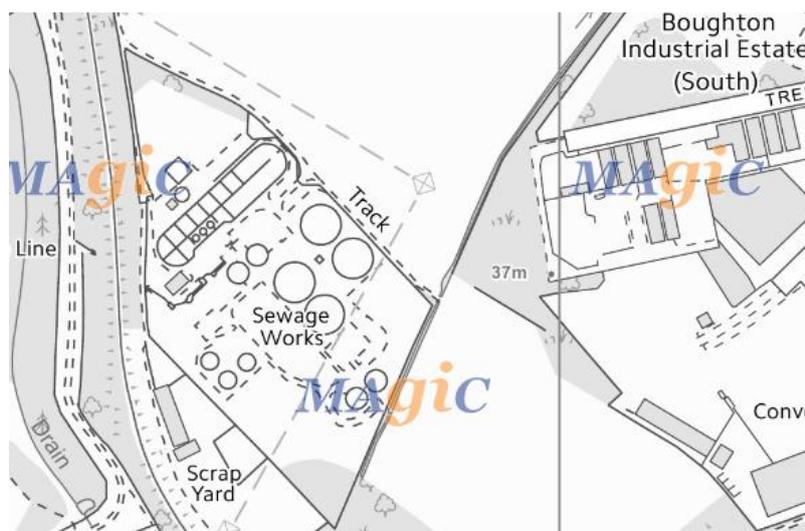
Figure 3 Boughton STW and adjacent farmland.

- Boughton STW (fig. 3) represents a potentially significant source of P and other substances to Bevercotes Beck. However it may also provides a significant proportion of baseflow to the watercourse.
- Reducing the nutrient loading of final effluent (or portion of) but maintaining discharge rate may help to reduce stress on aquatic biota.
- A constructed wetland containing P-stripping materials such as mining waste (ochre) and raw water treatment residuals may be installed onsite at the STW or in the adjacent agricultural land. A similar wetland system is currently being planned to treat effluent from Lound STW.
- The wetland may be planted with native reed species to increase nutrient uptake potential.
- Final treated effluent may then be passed through the wetland system before being released into Bevercotes Beck.

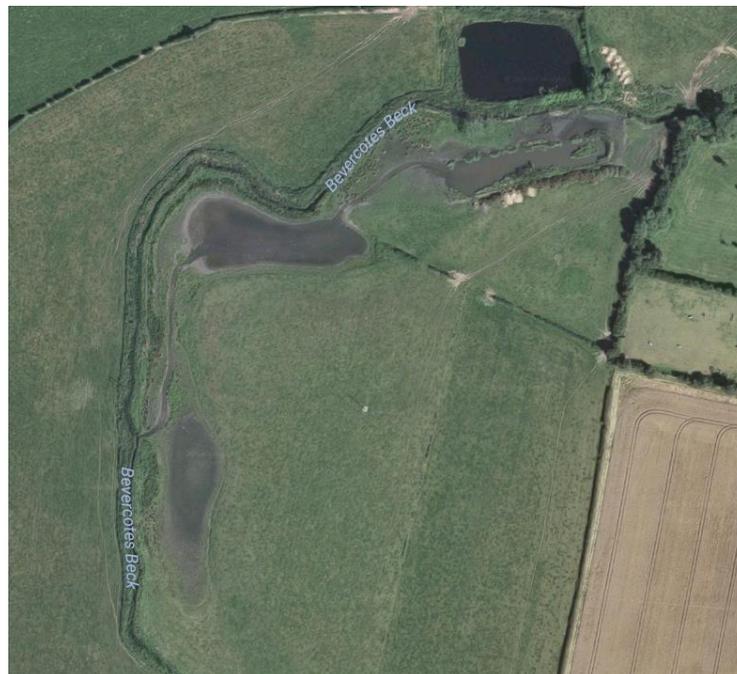
Figure 4 Site of potential in-channel wetland construction in saturated fields.

- Aerial images suggest that the beck at SK 6869 4331 (fig. 4) may naturally flood into adjacent riparian areas along the bottom of a shallow valley.
- The area, currently used to graze cattle, appears to be colonised by marsh species such as *Juncus* and also features a permanent irrigation/nature pond. This indicates that the ground may be highly saturated. The naturally wet condition of the area may therefore be exploited to form a series of vegetated ponds/wetland features.

- This may be achieved by excavating or diverting the current watercourse to form additional in-channel pools, particularly in locations which are known to collect surface water. Pools may include deeper central sections and shallower and wider marginal areas. Short, shallow meandering channels could be used to connect pools.

- The marginal zones of pools may be planted with native reeds or other macrophyte species, while connecting channels may be planted with species such as Water Crowfoot.

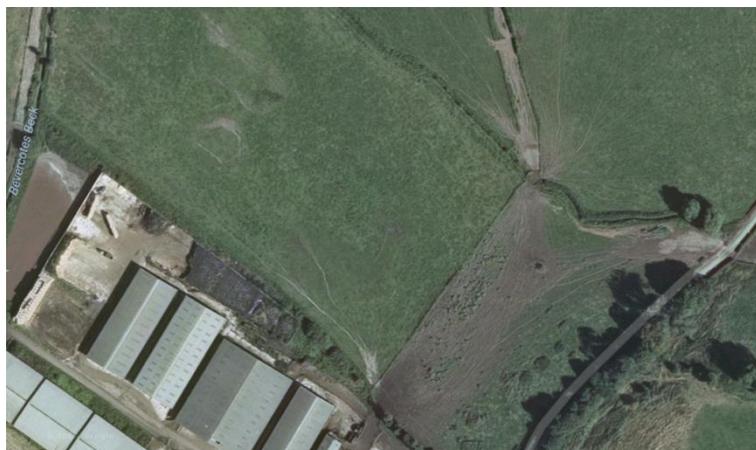
Figure 5 Evidence of soil erosion in tracks and gateways on Manor Farm, Kirton.

- Gateways, crossings and farm tracks at several locations adjacent to the watercourse or connected drainage channels, appear to be susceptible to soil erosion from vehicle or livestock movement e.g. SK 6969 1663 (Fig. 5)

- The location of these areas greatly increases the potential for direct transfer of sediment, nutrients and faecal matter into the waterbody. Therefore minimising sediment mobilisation and transfer is a priority.
- Bridging structures may be modified to include bunded or raised sides and access ways in order to direct polluted water away from the watercourse.
- Gateways and tracks may be reinforced by grass protection mats and railway sleepers. More heavily used areas may benefit from installation of hard-core or concrete pads to give a more durable surface
